Spot Safety Project Evaluation

Spot Safety Project # 02-00-208 / 02-00-209

Spot Safety Project Evaluation, Of Four Directional Crossover Installations on US 70 Near Havelock, in Craven County

Safety Evaluation Group
Traffic Safety Systems Management Section
Traffic Engineering and Safety Systems Branch
North Carolina Department of Transportation

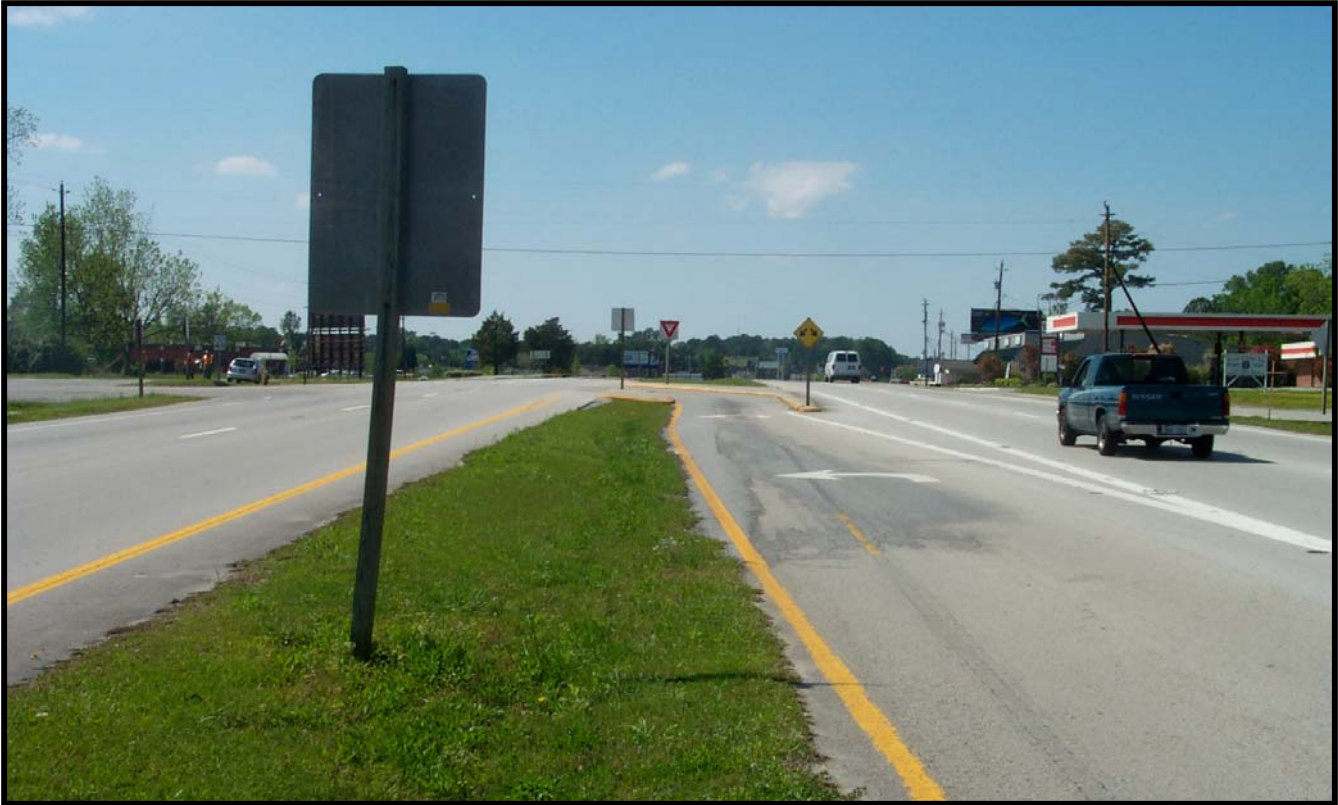
Looking north on US 70 at Crossover 4

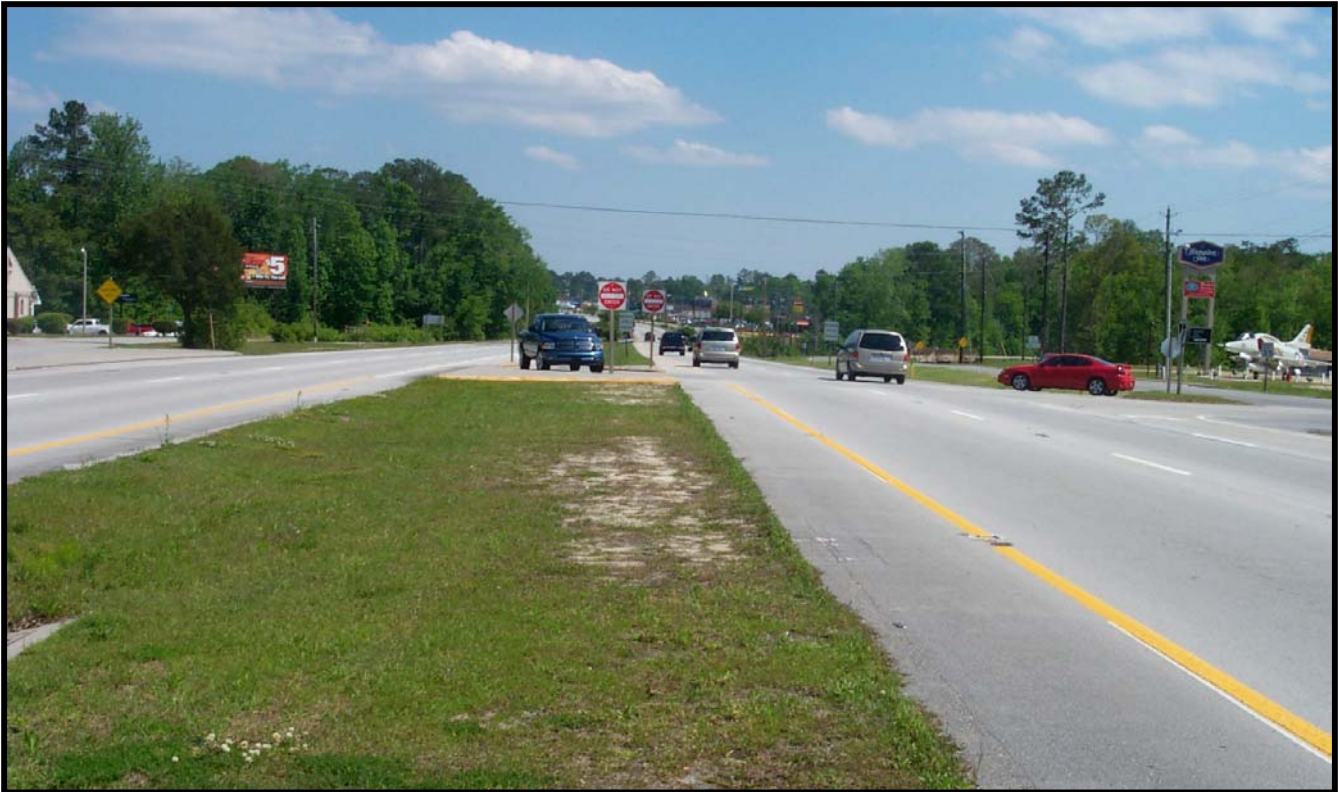
Looking south on US 70 at Crossover 4

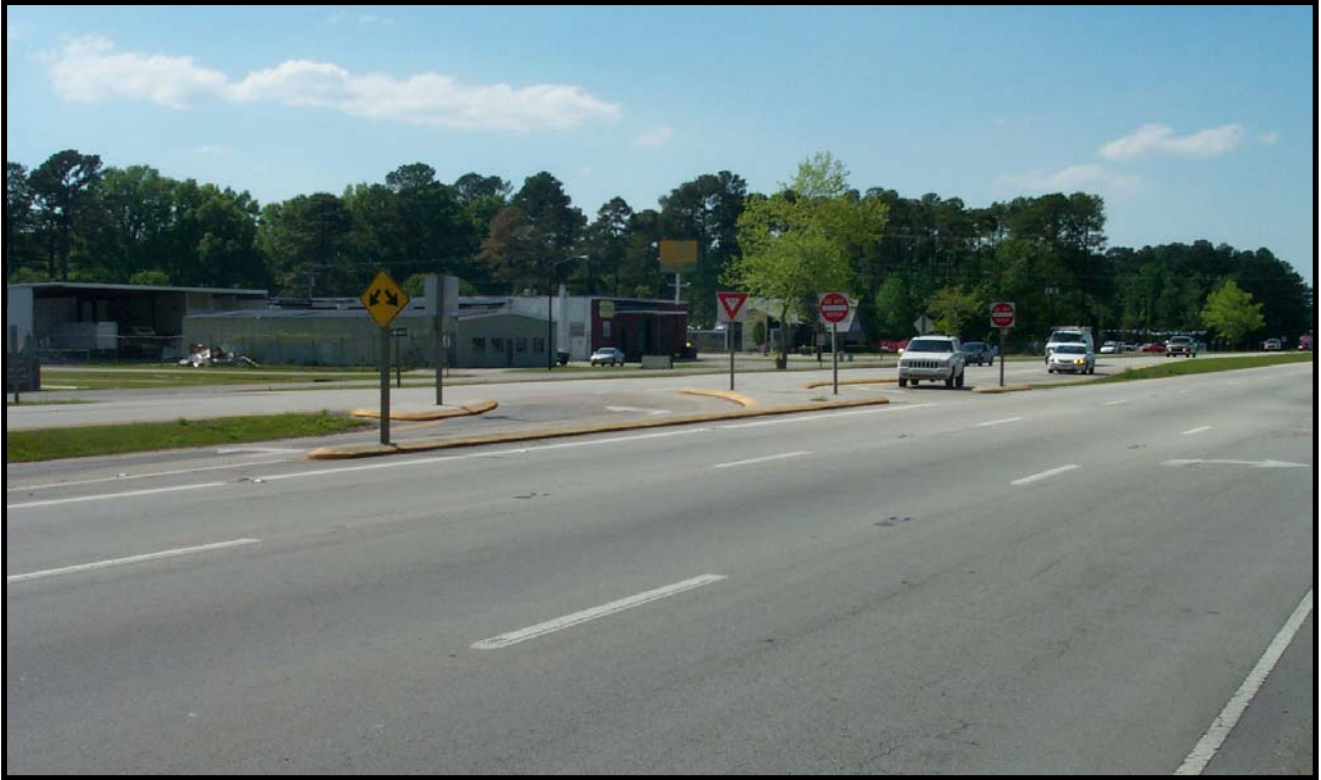
Looking north on US 70 at Crossover 3

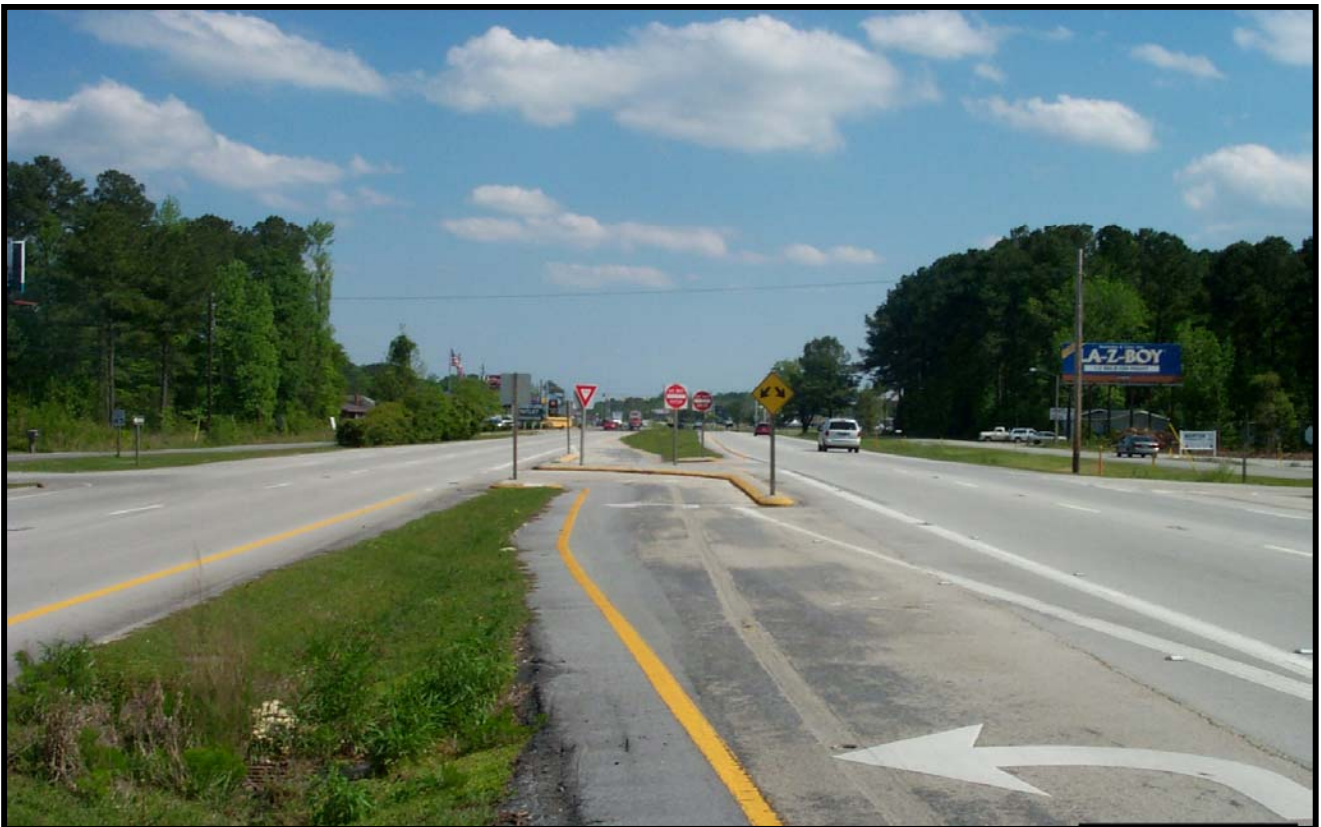
Looking south on US 70 at Crossover 3

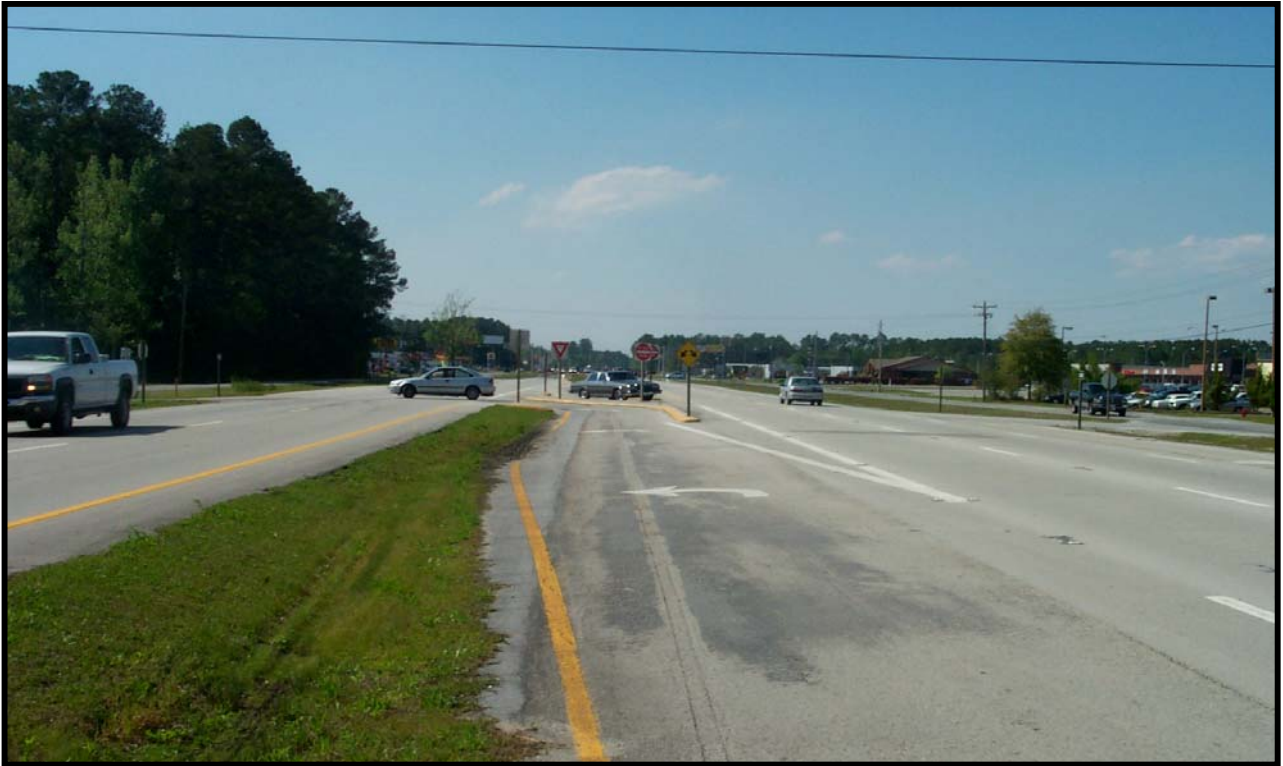
Looking north on US 70 at Crossover 2

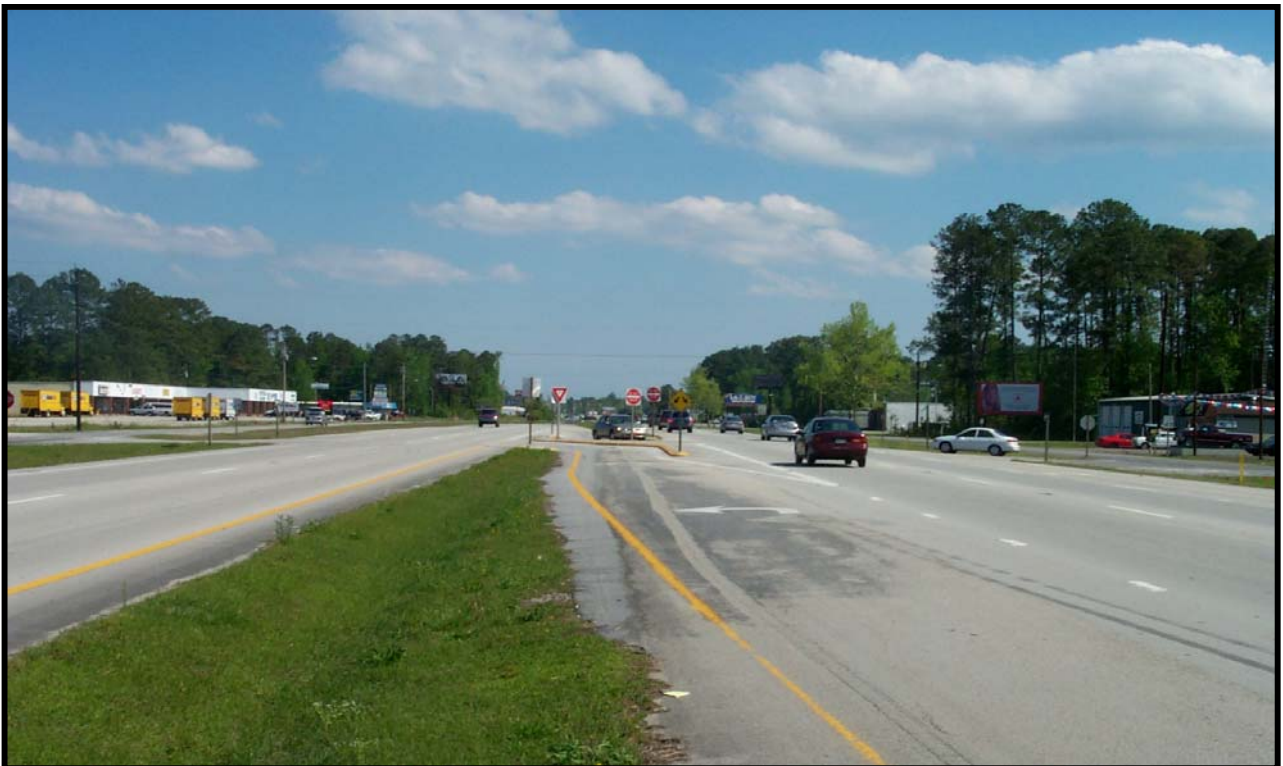
Looking south on US 70 at Crossover 2

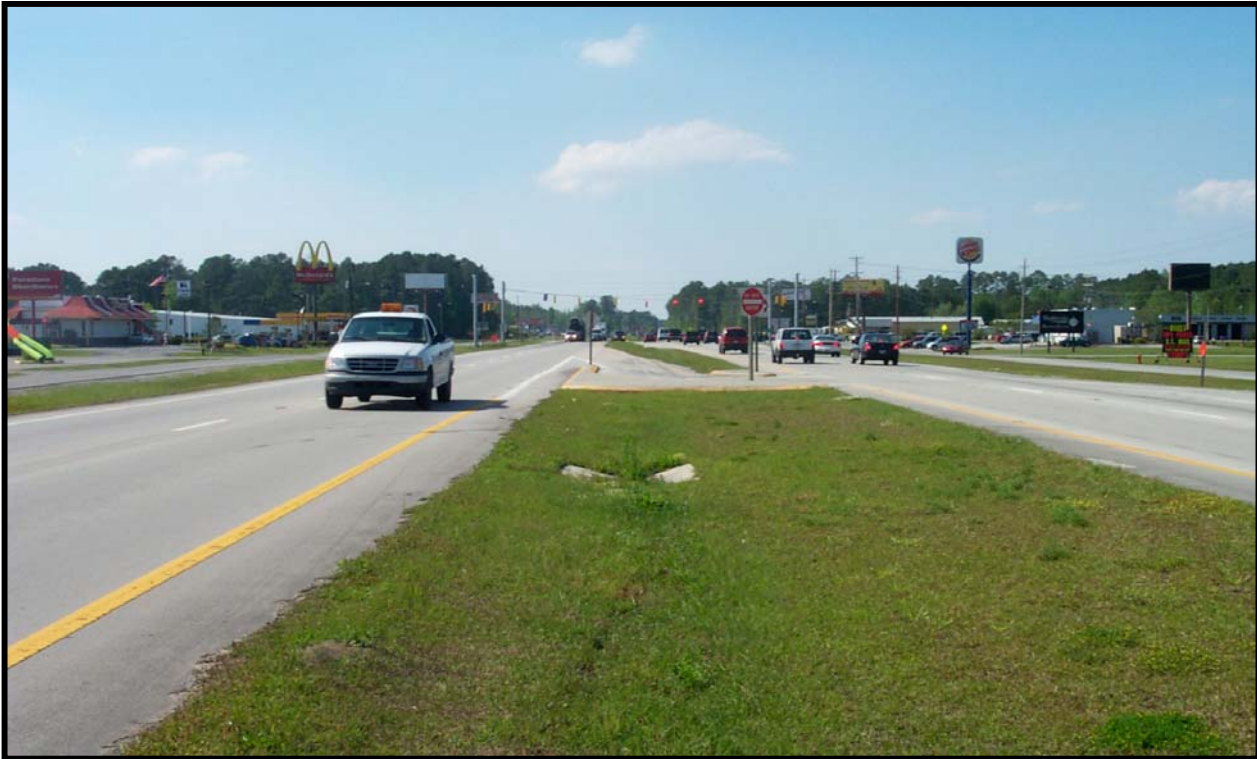
Looking north on US 70 at Crossover 1

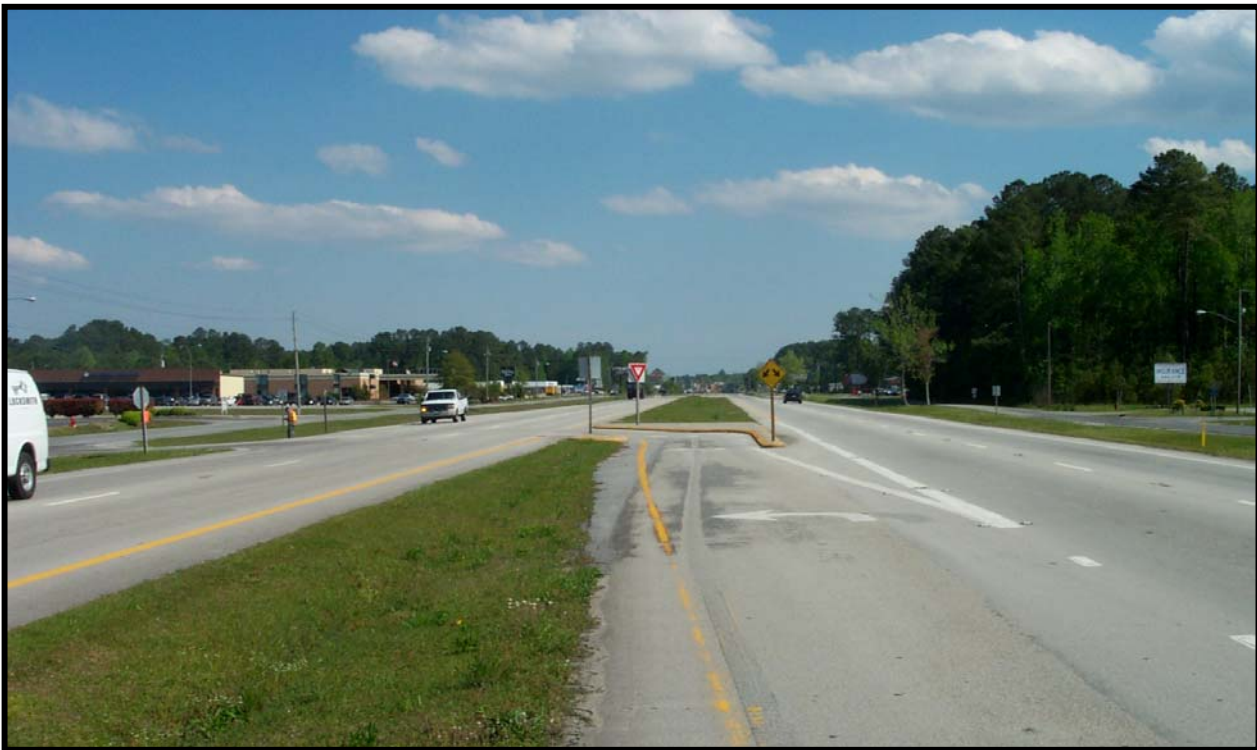
Looking south on US 70 at Crossover 1

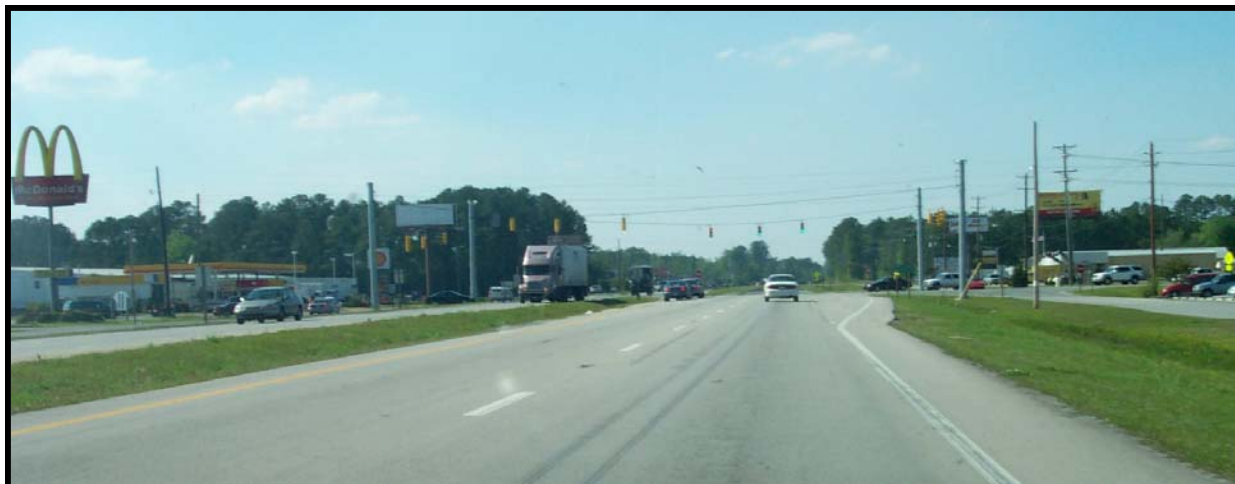
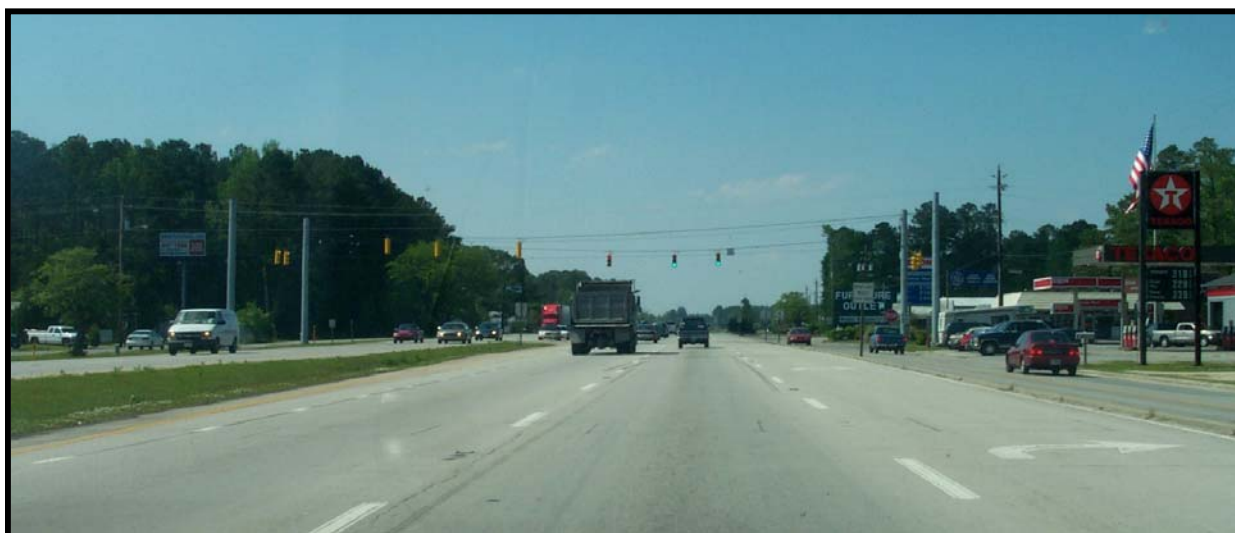
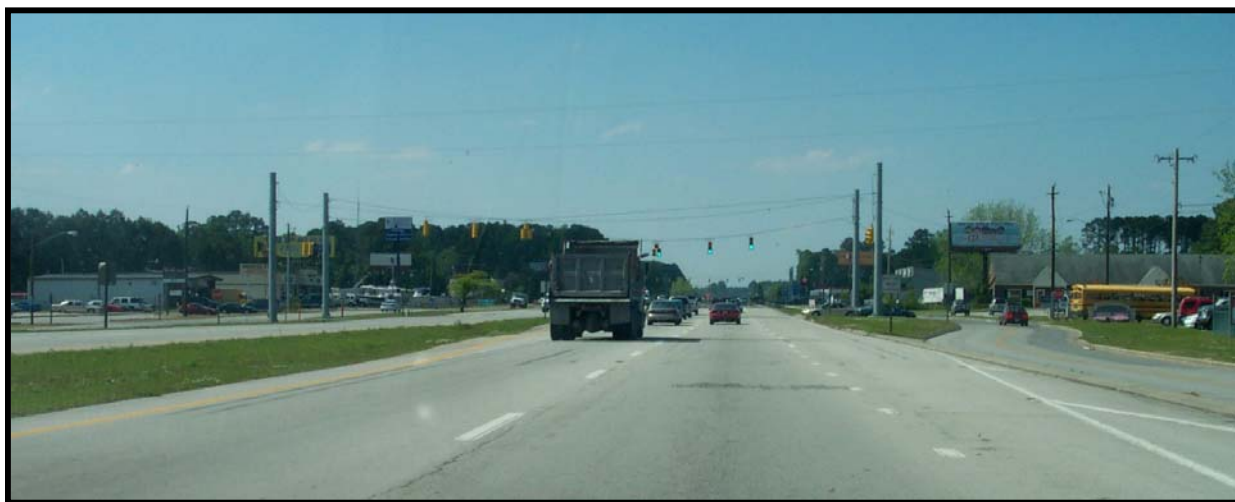
Photos taken while driving north on US 70
Top: US 70 at SR 1746-SR 1765-Catawba Road-Greenfield Heights Blvd
Middle: US 70 at SR 1757-Ketner Blvd
Bottom: US 70 at Stonebridge Trail

Please see the attached *Treatment Site Location Photos*. Photos are provided for each Treatment Crossover. In addition, photos taken at the three signalized intersections in the vicinity of the Treatment Locations are provided.
